# Ameri-Brand Products Inc

## Dome Heaters In Freezing Climates

DH-83.5.2  
rev-1-15-2021 TJM

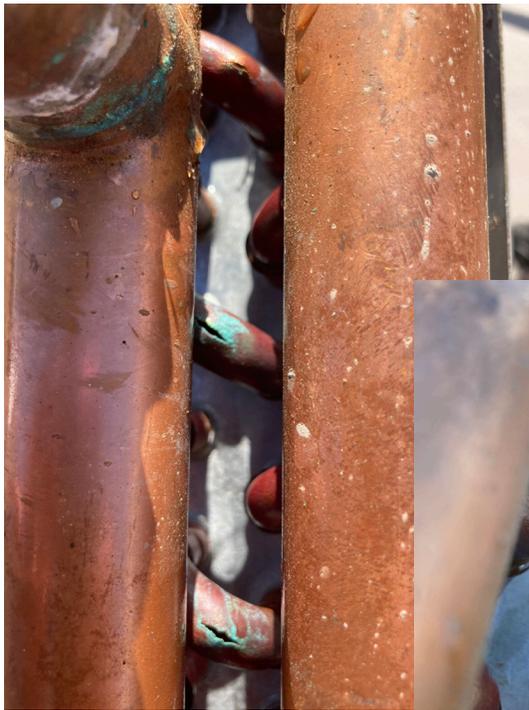
Example 1. Freezing of copper tubing showing split at the outside of radius where the tube is the thinnest due to the bending process. This split is not recent as the "tell tale" green oxidation stain where the water leaked out is moderate.

If the dome heater is to be operated in an area that experiences temperatures of 25 (F) or less, and the warm water supply is interrupted due to a power interruption or intentional turning off of the pool pump, the Dome Heater must be drained. In addition, compressed air needs to be blown through the hose and Dome Heater coil to evacuate any water left in the unit. Water remaining in the Dome Heater Coil can freeze and rupture the tubing where it's bent. This is the area on the tubing where the outside of the radius occurs. (see pictures below)

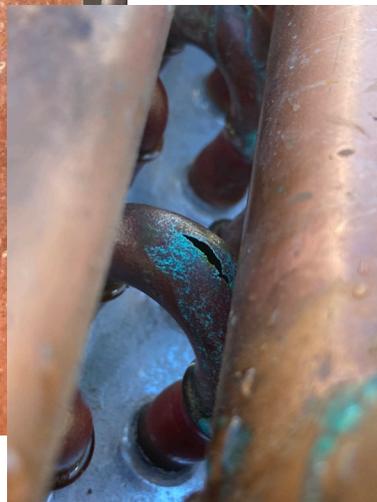
Staining on copper tubing is caused when the copper tube is exposed simultaneously to both water and air over time.

Example 2. Freezing of copper tubing showing multiple splits. The Coil shown is new and the freeze damage was noticed immediately. There is no corrosion evidence from long term leakage and oxidation.
